# Steel Manufacturing

## INCIDENT DESCRIPTION

## ROOT CAUSE

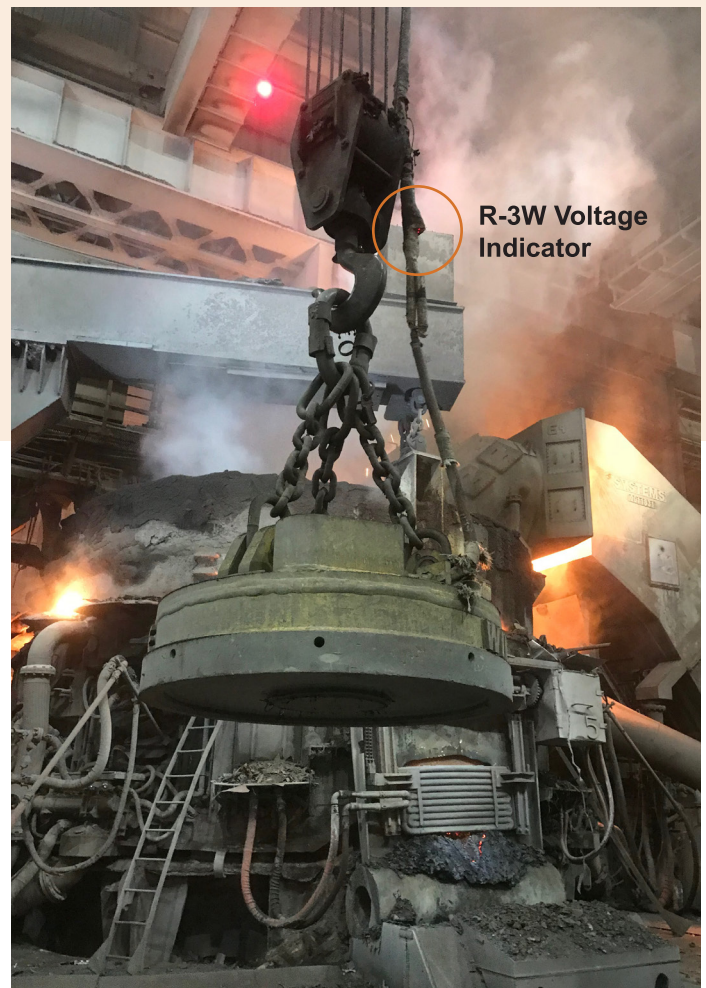
The root cause of these incidents was the failure to recognize that the magnet cables were energized. The cranes have indicator lights on the bridge indicating power to the magnet. However, due to circumstances; could be hard to see or the employee just forgets to check.

*The U.S. Department of Labor reported an average of 2,370 non-fatal electrical injuries per year due to electric shock and or electrical burns. Grace PESDs® help to identify all possible sources of electrical supply to specific equipment, such as the magnetic crane shown above.*

The addition of Voltage Indication at the connection point of the cables will give an added level of safety awareness. Adding a Permanent Electrical Safety Device (PESD), such as the model R-3W Voltage Indicator; a couple of feet above the connectors will provide a visual indicator at eye level. The R-3W LEDs will blink when energized and none when off.
